Soviet Moon rocket plunges to the ground after a minute in flight

The USSR's first attempt to launch its giant N1 rocket on Feb. 21, 1969, ended in a crash, but its creators do not give up hope just yet.

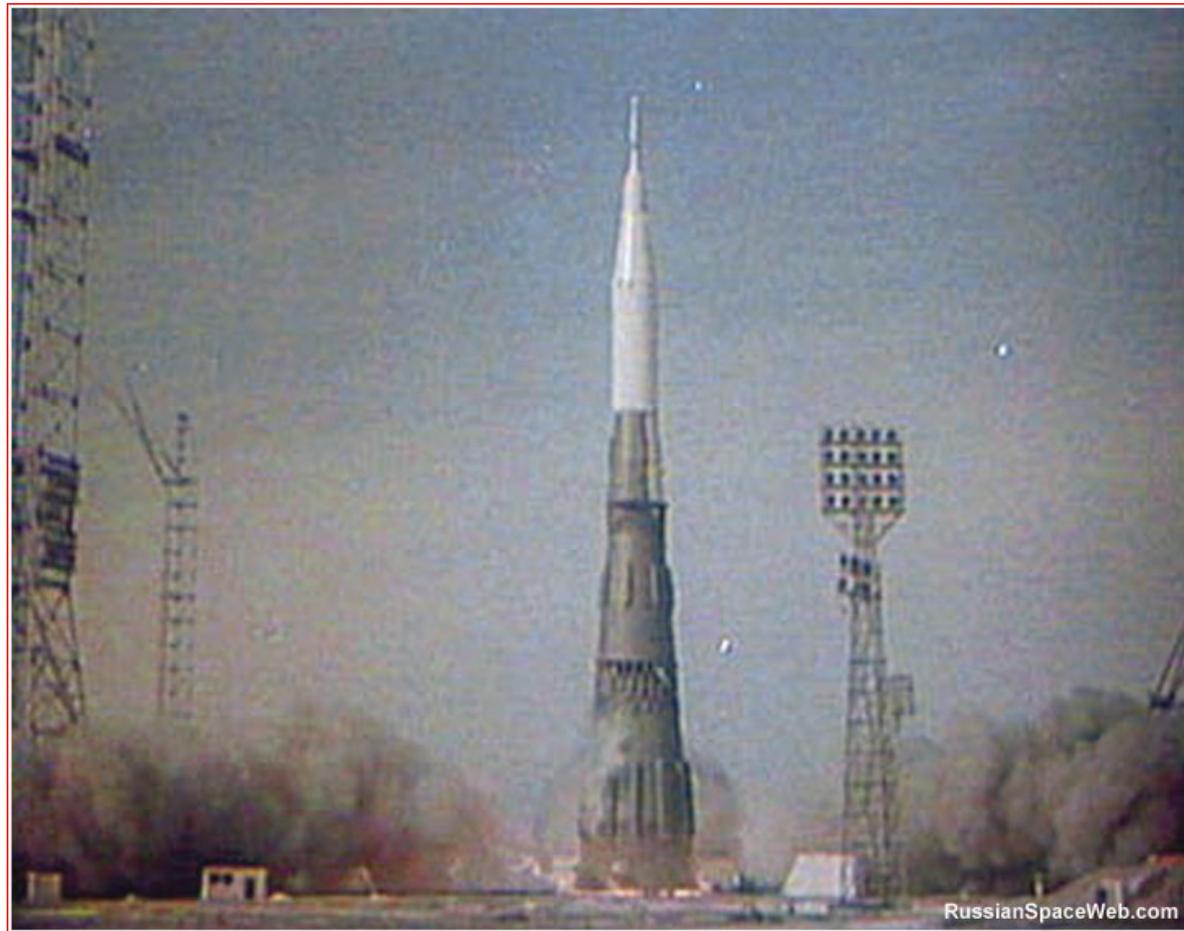
The USSR's colossal N1 Moon rocket lifts off for the first time on Feb. 21, 1969, at 12:18 Moscow Time.

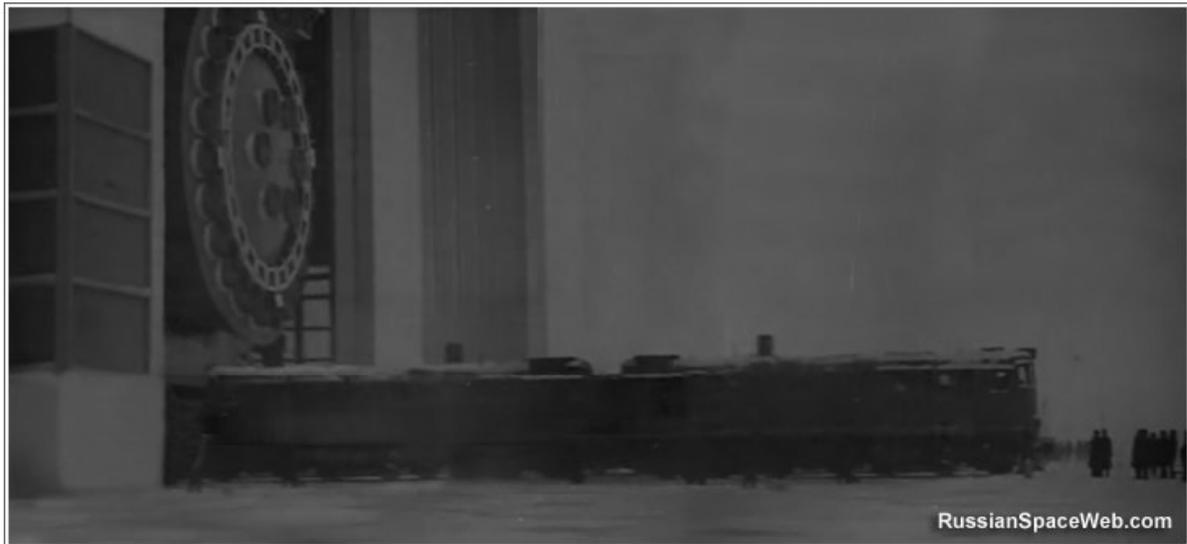
The N1-3L rocket emerges from the vehicle assembly building on the snowy day of February 9, 1969.

The critical meeting of the State Commission in Tyuratam on February 9, 1969, had the goal of confirming the official launch date for the first N1 rocket and clearing it for the rollout to the launch pad on the same day. The heads of the N1-L3 development, Boris Dorofeev and Boris Filin, reported on the results of the tests, followed by short statements from other key project officials.
